Manhole Inspection Summary

Manhole # S17S__012MH

Insp Date: **5/5/09 9:29 AM**

Location Address: **1500 CARROLL PARK**

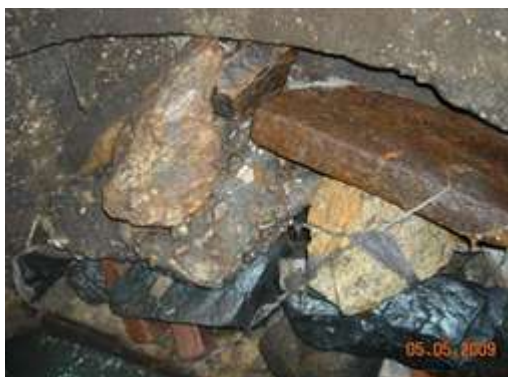
Defect 7

Condition: ☐ Sound ☐ Cracked ☐ Root Intrusion ☐ Deteriorated ☐ Leaks ☒ **Debris**

DEBRIS STACKED ON BENCH

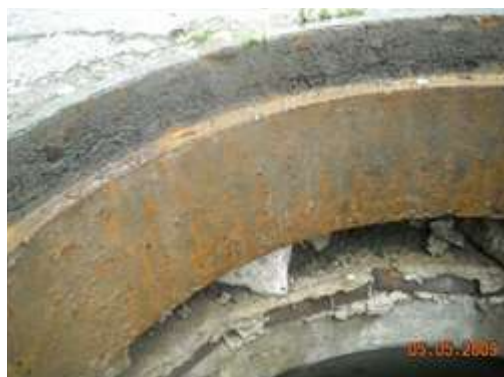
Defect 6

Frame Offset: **2** (in.) Condition: ☐ Sound ☐ Cracked ☒ **Leaks**

FRAME LEAKS

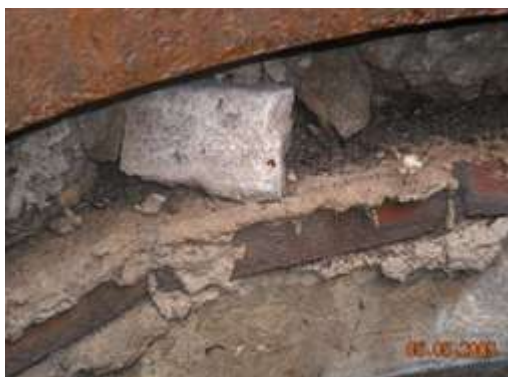
Defect 5

Condition: ☐ Sound ☒ **Cracked** ☐ Root Intrusion ☒ **Loose Brick** ☒ **Deteriorated**

LOOSE CHIMNEY MATERIAL

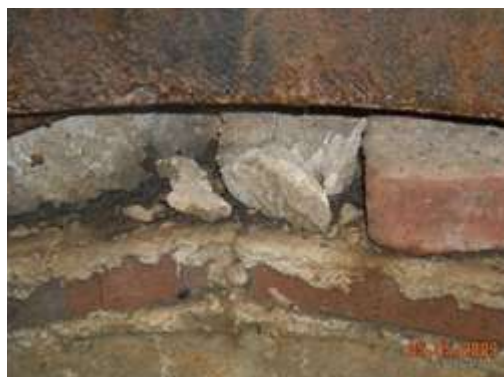
Defect 4

CRACKED CHIMNEY MATERIAL

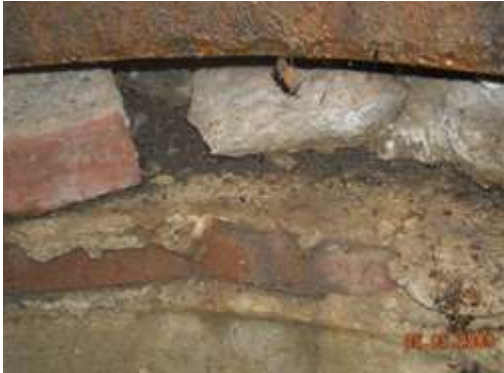
Defect 3

DETERIORATED CHIMNEY

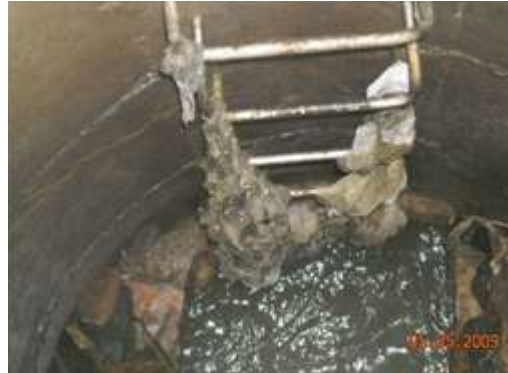
Defect 2

Surcharge ☒ **Evidence Of Surcharge** Depth: **8** (ft.) ☐ Active Surcharge Present

EVIDENCE OF SURCHARGE

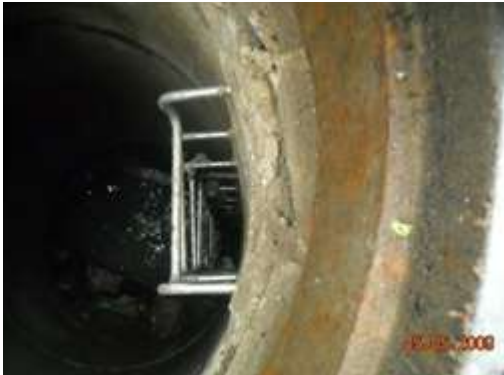
Defect 1

FRAME OFFSET

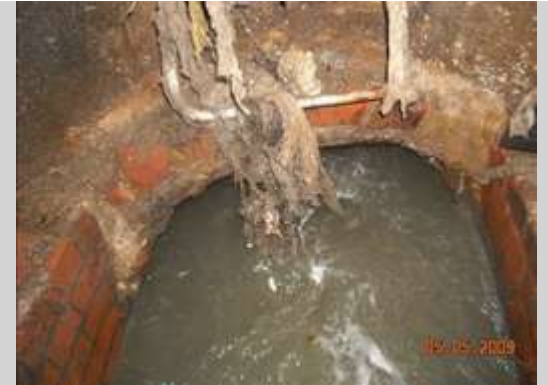
12 O'Clock Outflow

27 in. Circular Gravity Sewer
Pipe Out @ 12 O'Clock

Pipe Height: **27.6** (in.) Rod and Bar (Angled)
Pipe Material: **Clay** ☐ Pipe Lined
Invert Depth: **14.70** (ft.) Flow Characteristics: **Fast**
Deposits: ☒ None ☐ Mud ☐ Sludge ☐ Debris ☐ Grease
Silt Depth: **0** (in.) Deposits Extent:
Infiltration: **None** Pipe Seal Cond: **Sound**

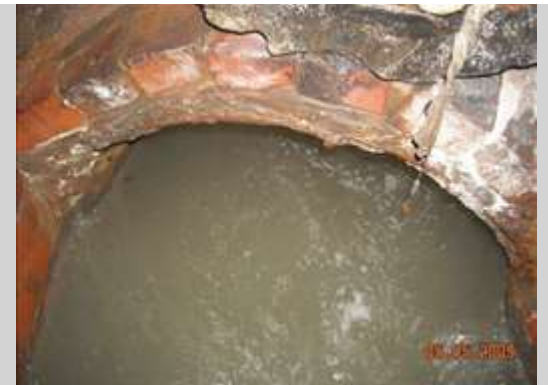
7 O'Clock Inflow

27 in. Circular Gravity Sewer
Pipe In @ 7 O'Clock

Pipe Height: **27.6** (in.) Rod and Bar (Angled)
Pipe Material: **Clay** ☐ Pipe Lined
Invert Depth: **14.45** (ft.) Flow Characteristics: **Fast**
Deposits: ☒ None ☐ Mud ☐ Sludge ☐ Debris ☐ Grease
Silt Depth: **0** (in.) Deposits Extent:
Infiltration: **None** Pipe Seal Cond: **Sound**
